Re: E.E. Smith House at 135 Blount Street Fayetteville, North Carolina Our Job No. 16-19

As requested by you a preliminary visual structural inspection was made on February 19, 2016 at the above referenced house. The purpose of the inspection was to determine the general structural condition of the house. Small openings were made by your office in the floor to access the crawl space. The attic was accessed through an opening in the 2nd floor ceiling. Plaster and wood lathe was removed from the interior side of exterior walls in selected areas to inspect the wall studs. The following is a summary of our findings:

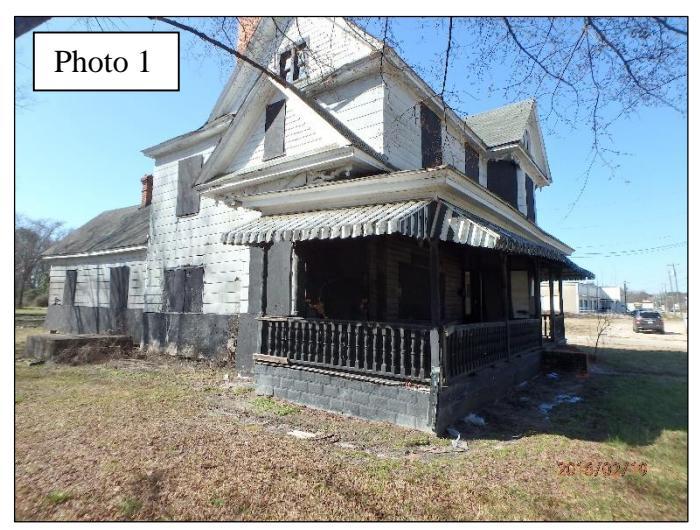
The house is a two-story wood framed structure built over a crawl space (photo 1). The house framing is supported on a brick masonry perimeter pier and curtain wall foundation and 8 inch by 24 inch interior brick masonry piers.

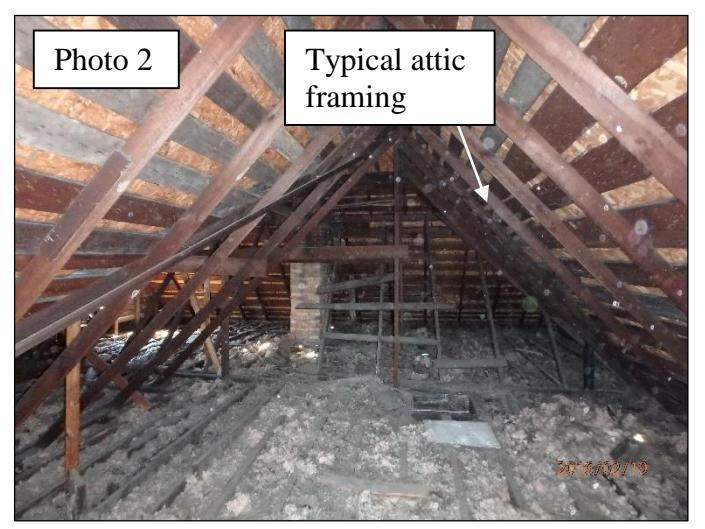
The roof is a steep slope gable and hip roof. The roof framing consists of rough sawn 2x4 rafters at 32 inches on center supported on 2x5 ceiling joists spaced 16 inches on center (photo 2). The rafters and ceiling joist appear in fair condition with the exception of a large area at the middle rear of the two-story section of the home (photo 3). A large opening in the roof has allowed

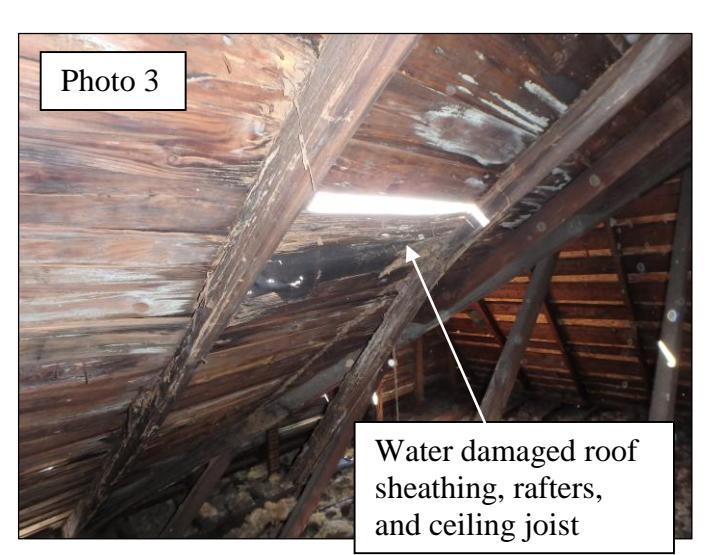
significant water entry and consequential damage to the wood framing from the roof to the crawl space due to long term exposure to moisture.

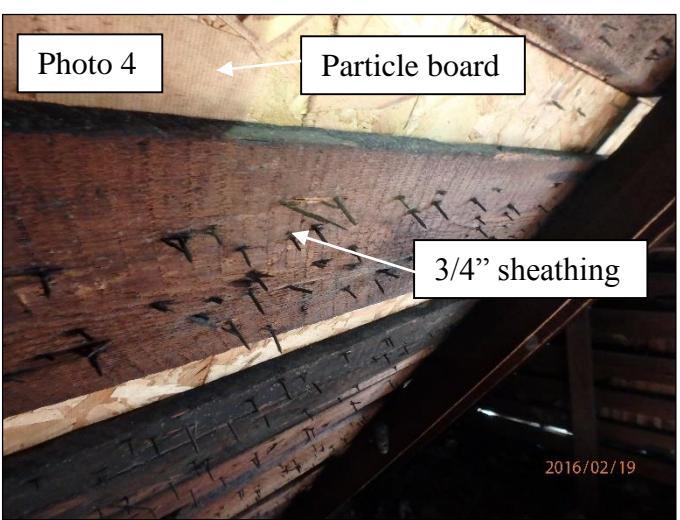
The original roof sheathing is ³/₄ inch spaced sheathing that is overlaid with a newer composite board (photo 4). There are numerous nails in the spaced sheathing. In most locations the original sheathing was in fair condition. In one location at the left rear of the two-story area the sheathing has minor fire damage (photo 5).

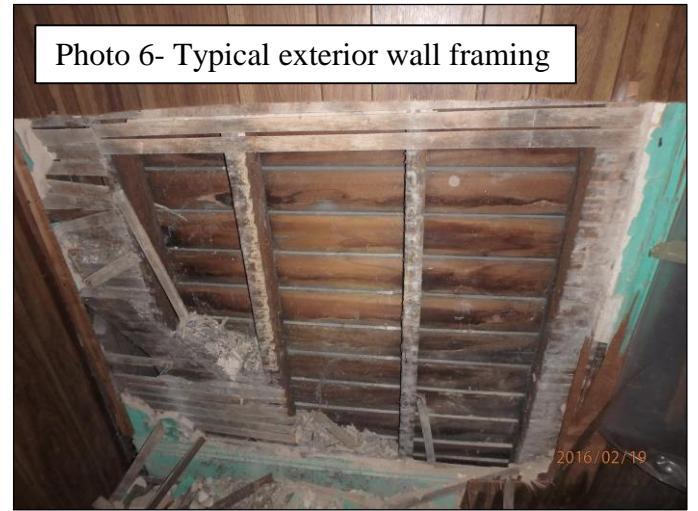
The exterior wall studs are rough sawn 2x4 @ 16 inches on center and appear in fair condition in most areas exposed to view with the exception of the area with the roof leak (photo 6). The exterior wall studs at each side of window openings are rough sawn 4x4 timbers which appear in fair condition in most areas.

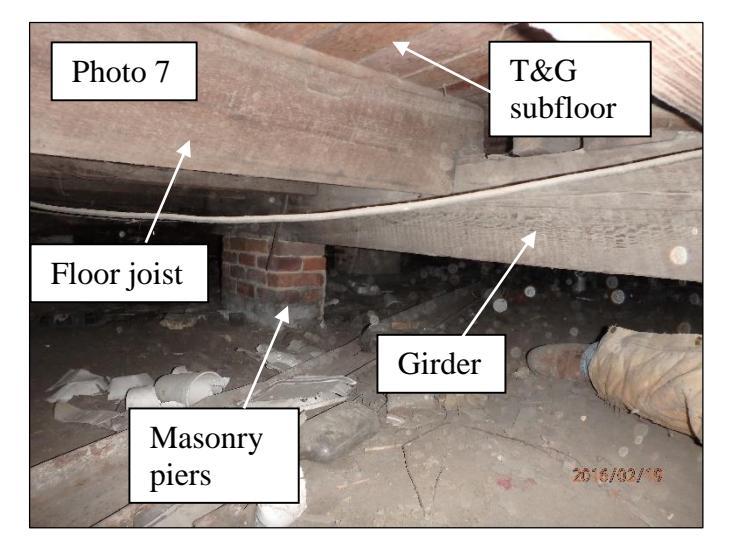
The floor joists in the crawl space are rough sawn timbers of various sizes spaced approximately 20 to 24 inches on center (photo 7). The girders below each hallway wall in the two-story area are 8x8 timbers. The crawl space framing appears in fair condition.

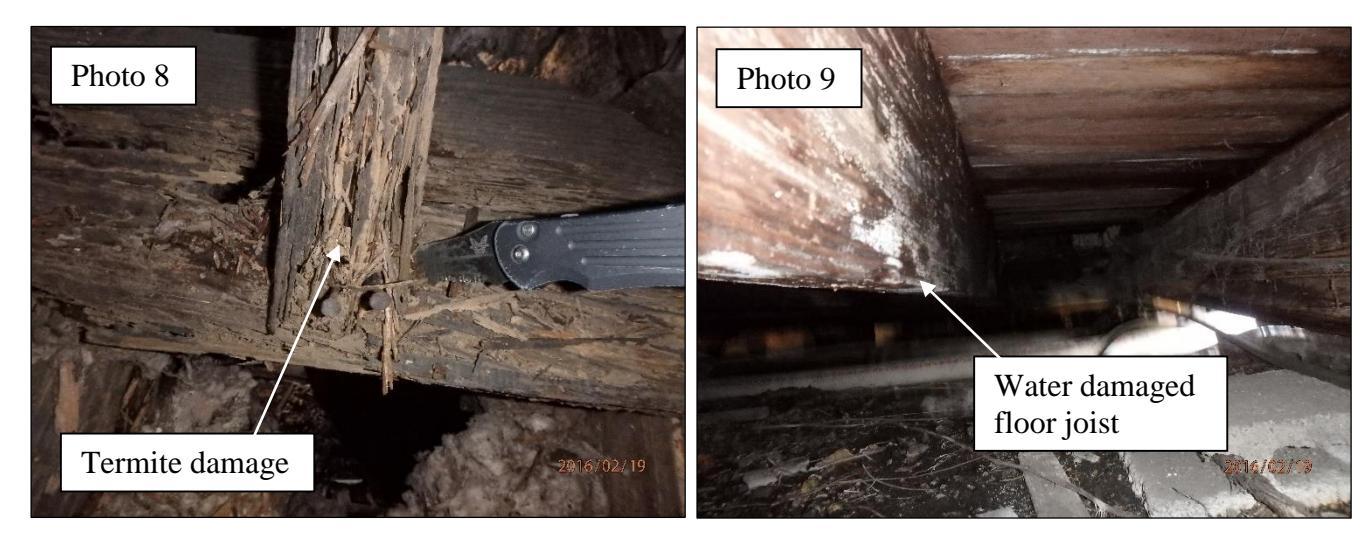
In conclusion, the majority of the wood structural framing in the house is in fair condition with noted exceptions and should be able to provide continued service life. There are several pockets of water or termite damage especially below the roof leak in the two-story area and in the one-story section of the house (photos 8 and 9). There are also areas where the masonry fireplace and perimeter foundation wall need repair.
